WA-I-508 Frame House

Hagerstown Vicinity

Maryland Historical Trust State Historic Sites Inventory Form

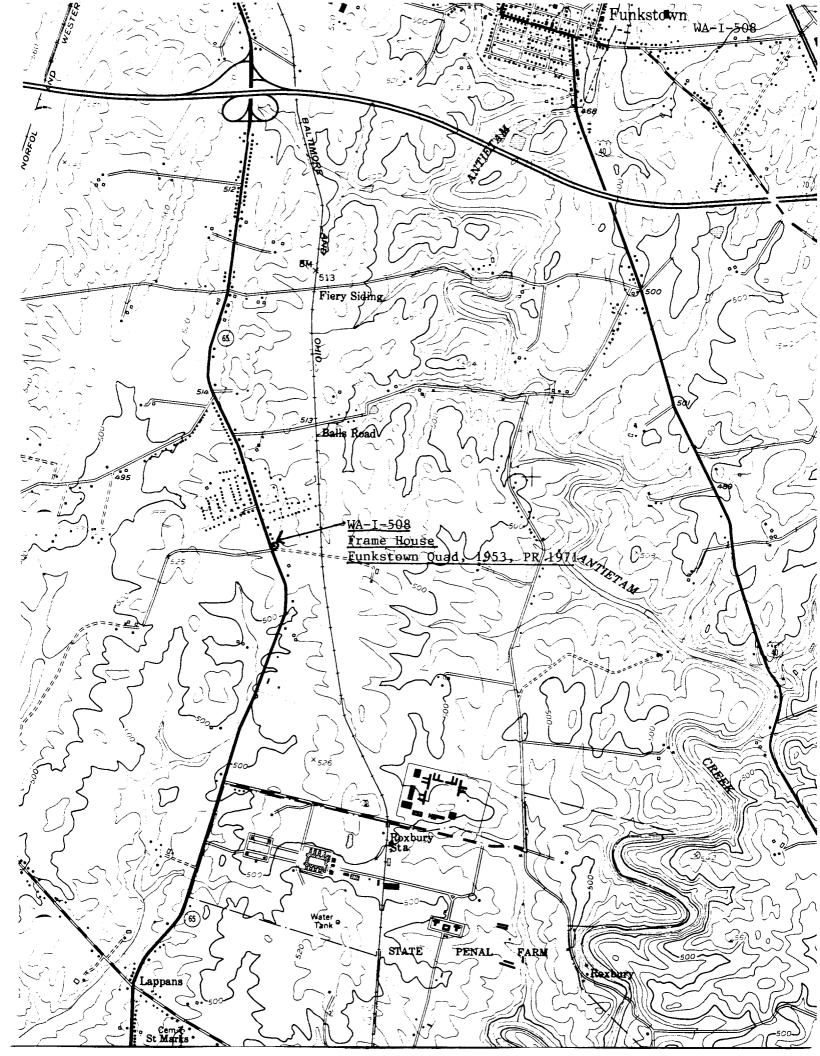
- Frame House WA-I-508
- Washington County, Maryland
- 3. Joe Getty
- May 1983 4.
- Maryland Hist. Trust, Annapolis, Md. 5.
- West Elevation; camera facing east
- 6. 7. 1/1

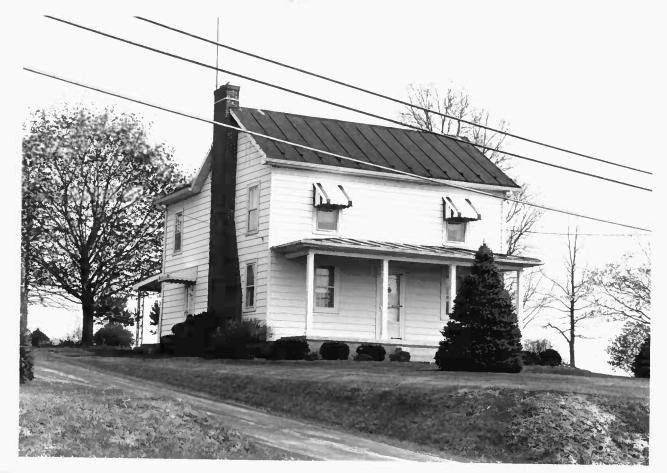
The main facade has a three-bay first story with a central entrance. Oneover-one sash windows are in the two bays on the first story and the second
story. The second story windows have black and white aluminum awnings. The
one-story porch has boxed posts supporting a hipped roof. The house is covered
in modern aluminum siding. The northern gable end has a exterior end brick
chimney that also appears to be a modern addition. On the north side of the
ell is a rear entrance to the house.
